the Christian Aviator

April 2014

Beware the 'bye-bye beat-up'

Beware the 'bye-bye beat-up' - Continued

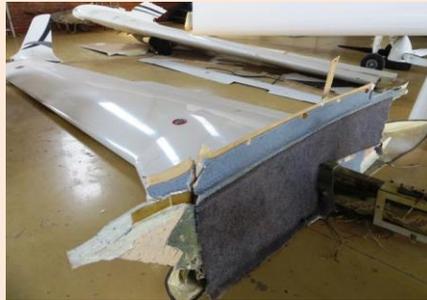
Detached starboard wing

The images show the remains of an aircraft involved in-flight break-up. No formal findings have been made. However, those involved in 'extreme flying' would do well to remember....

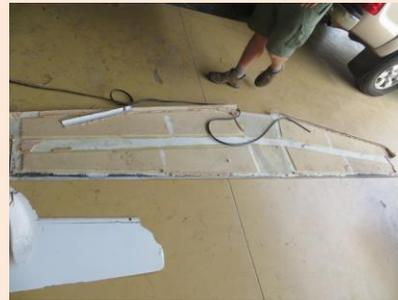
De-laminated horizontal stabilizer

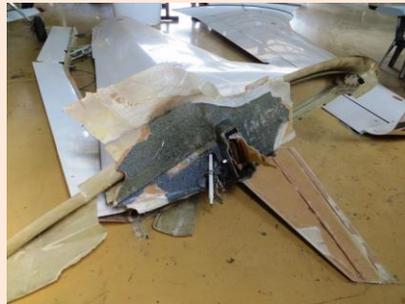
Detached port wing

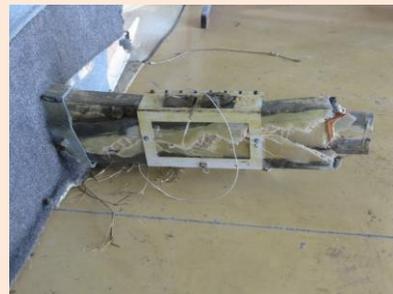
Shattered main-spar
